Environmental cost of flooding

A report by URBED (Urbanism Environment and Design) Ltd as part of the Big Lottery funded 'Rebuilding Together' project in Cumbria.

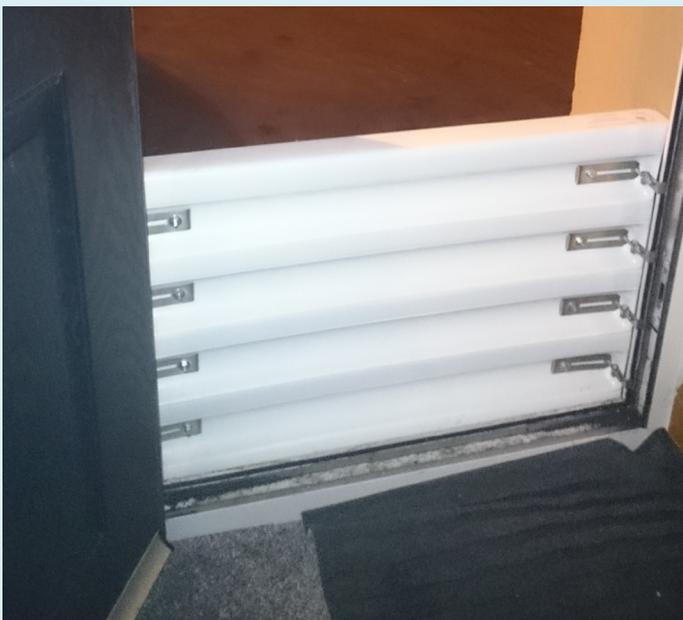
Above: flood doors fitted by previous owner

In the event, the flood gates offered little protection, as water found its way through cracks in the wall and other routes and eventually over-topped them. One of the flood gates (to the most critical rear elevation) appeared to fail as it had been badly fitted. The house has solid floors, so water coming up through the floor was not a factor.

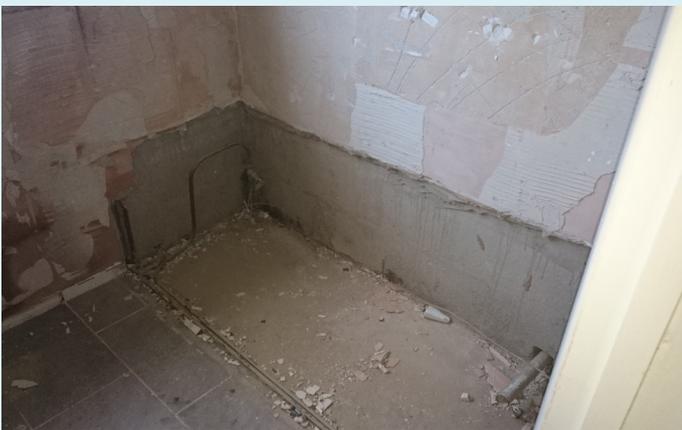
Above: the stripped out bathroom

Despite being fully tiled, the householder felt the walls in the bathroom had to be stripped as they were sodden and unable to dry otherwise. The bath, WC and hand-basin were all stripped out. Although the insurer argued the hand-basin might have been saved, the householder was able to argue for its replacement, and took these out themselves. The fitted kitchen was completely removed (chipboard based), and again taken to the HWRC by the householder.

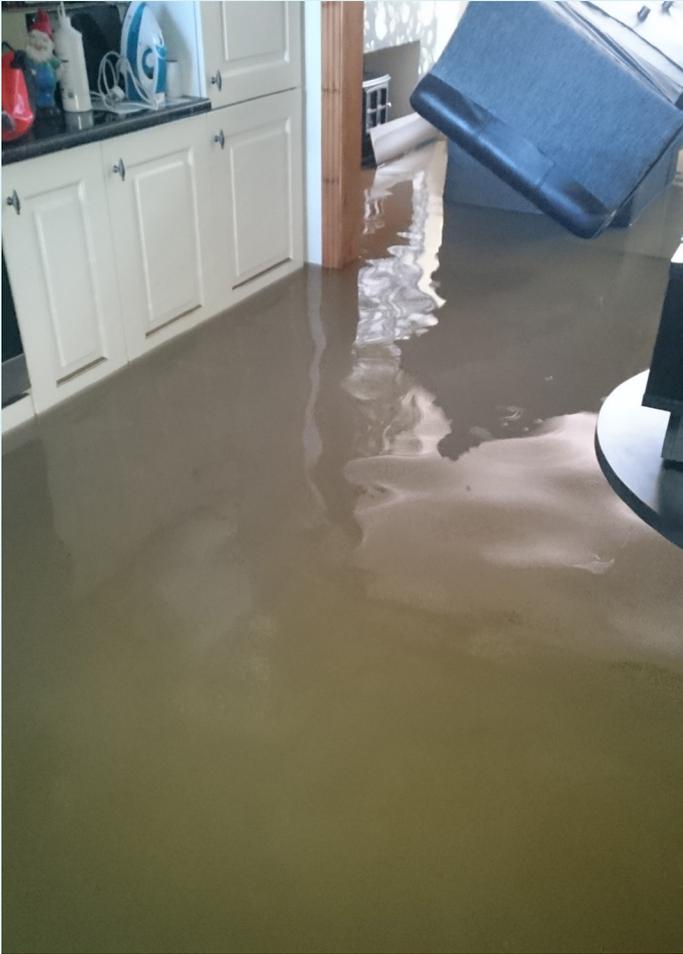
Flooding badly affected the kitchen and bathroom. The householder tried to move items like sofas above the flood water.

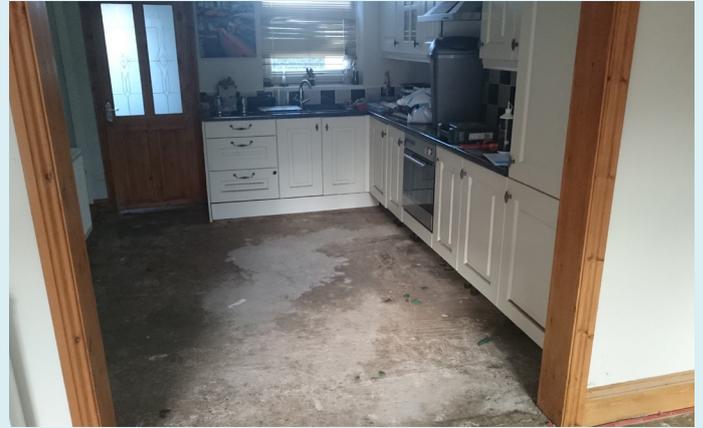
Tiles in the kitchen floor were stripped out and replaced.

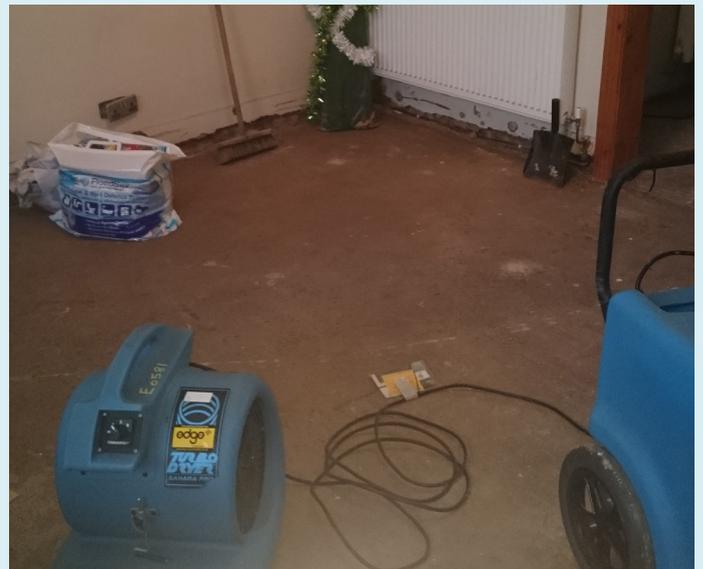
Drying out was by electric heaters and dehumidifiers.

Drying out was undertaken with electric heaters and electrically powered dehumidifiers, supplied by the contractor. The process took around a month and used a

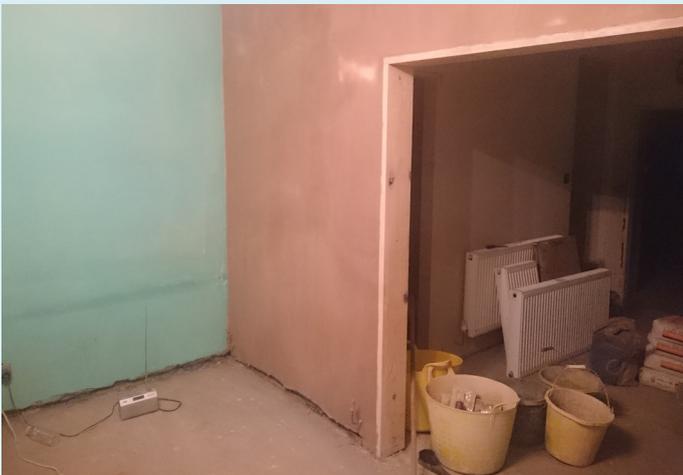
Re-plastering in the living room.

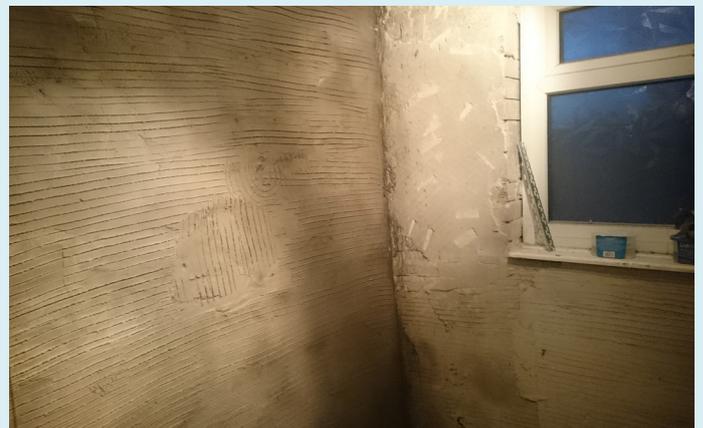
Bathroom tiles were also removed and replaced.

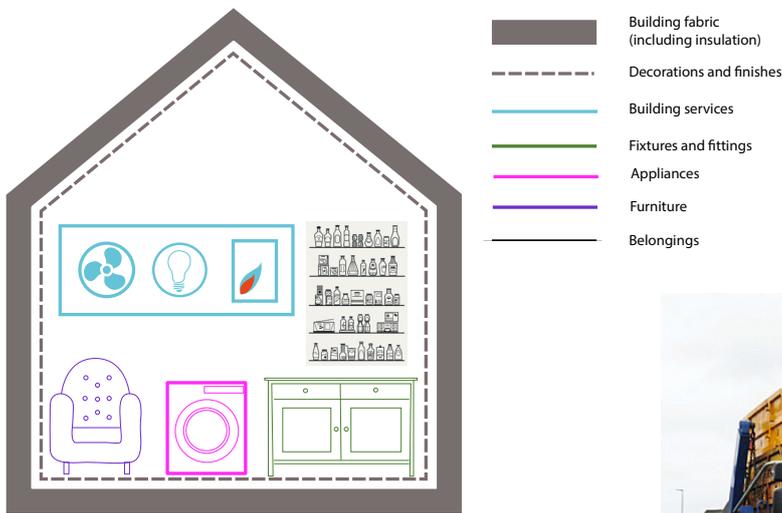
Above: Any home contains layers or construction and materials, all of which behave differently and need to be treated differently in any flood recovery process.

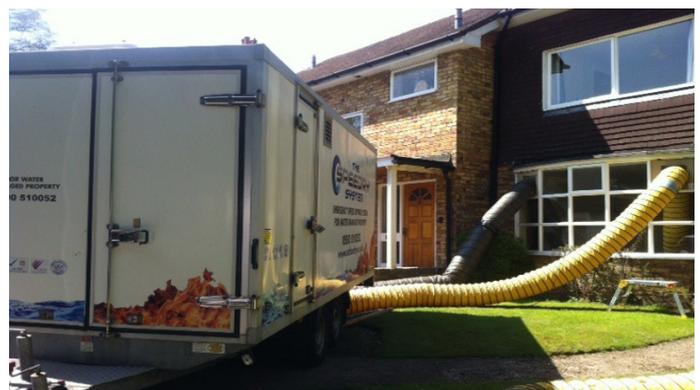
Above: speed drying trailer

Speed drying systems are typically mobile trailer units designed to heat multiple rooms to over 60°C. As independent units they are not reliant on the existing heating or electrical system of the home. Whilst this may reduce electricity costs to the householder, and may also mean the process can start more quickly - saving subsequent damage from prolonged dampness - they use diesel or petrol generators for power. These emit particulates and carbon monoxide which contribute to poor local air quality and create noise. The main unit usually pumps heat to smaller heat exchangers throughout the home; which usually have a power rating of 10, 30 or 60kW (ISS Restoration, online). The power used by such systems is therefore considerable.

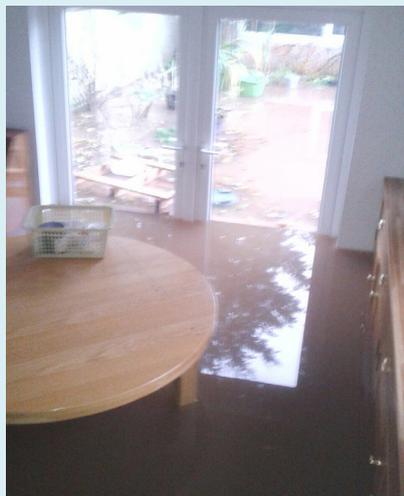
Right:
The flood water reached 1.3m at the rear of the house.

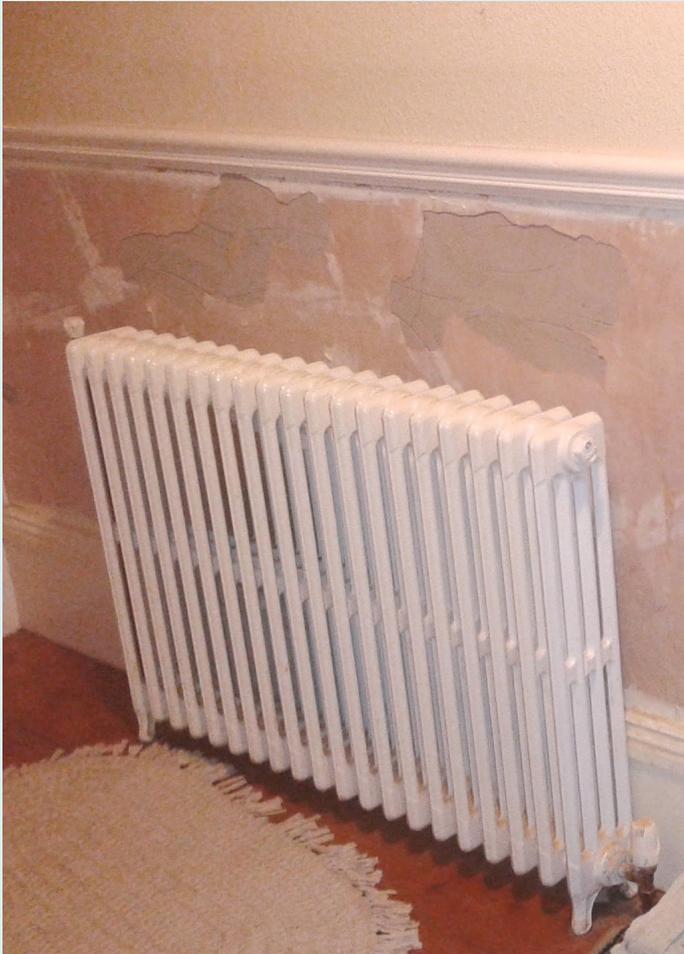
Some areas of skirtings, such as behind radiators, were not removed.

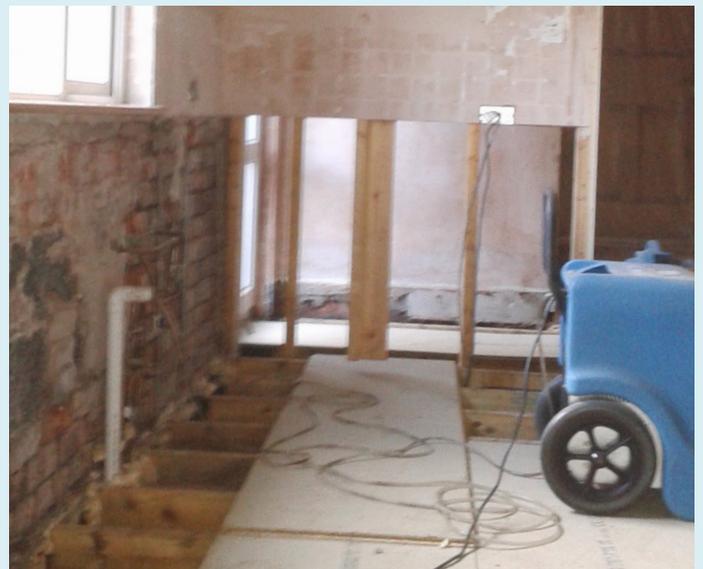
Drying out was by the gas central heating and dehumidifiers.

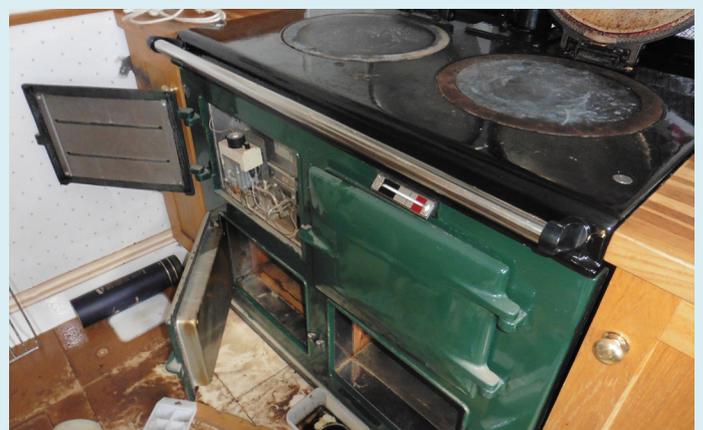
The AGA had to be replaced again after showing signs of rust.
